U.S. Department
of Transportation
**National Highway
Traffic Safety
Administration**

ODI RESUME

INVESTIGATION: EA00-020
DATE OPENED: AUG - 10 2002 DATE CLOSED: 9-OCT-02
SUBJECT: Ignition Switch Failure Resulting in Potential Loss of
Headlamp and Windshield Wiper Function
PROMPTED BY: PE00-006
PRINCIPAL INVESTIGATOR: Jeffrey Quandt

ENGINEERING ANALYSIS CLOSING REPORT

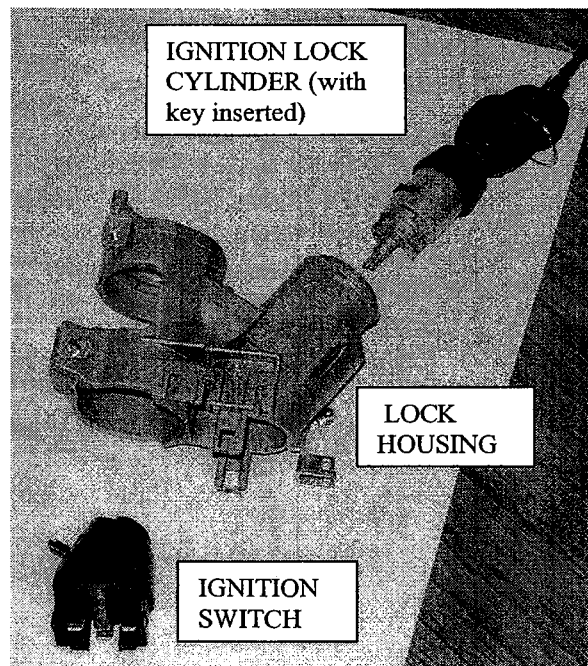
FIGURE 1. Subject Components.

DESCRIPTION OF COMPONENT/VEHICLE SYSTEM: The subject components include the ignition switch, the ignition lock cylinder, and the switch cylinder housing (Figure 1).

When the ignition switch is turned to the "START" position by turning the key in the lock cylinder, power is interrupted to the Power Accessory Circuit which includes the headlamps, windshield wipers, air-conditioning system, and day-time running lights (where applicable). When the key is released, a spring in the ignition switch returns the switch, lock cylinder, and key to the "RUN" position, returning power to the Power Accessory Circuit.

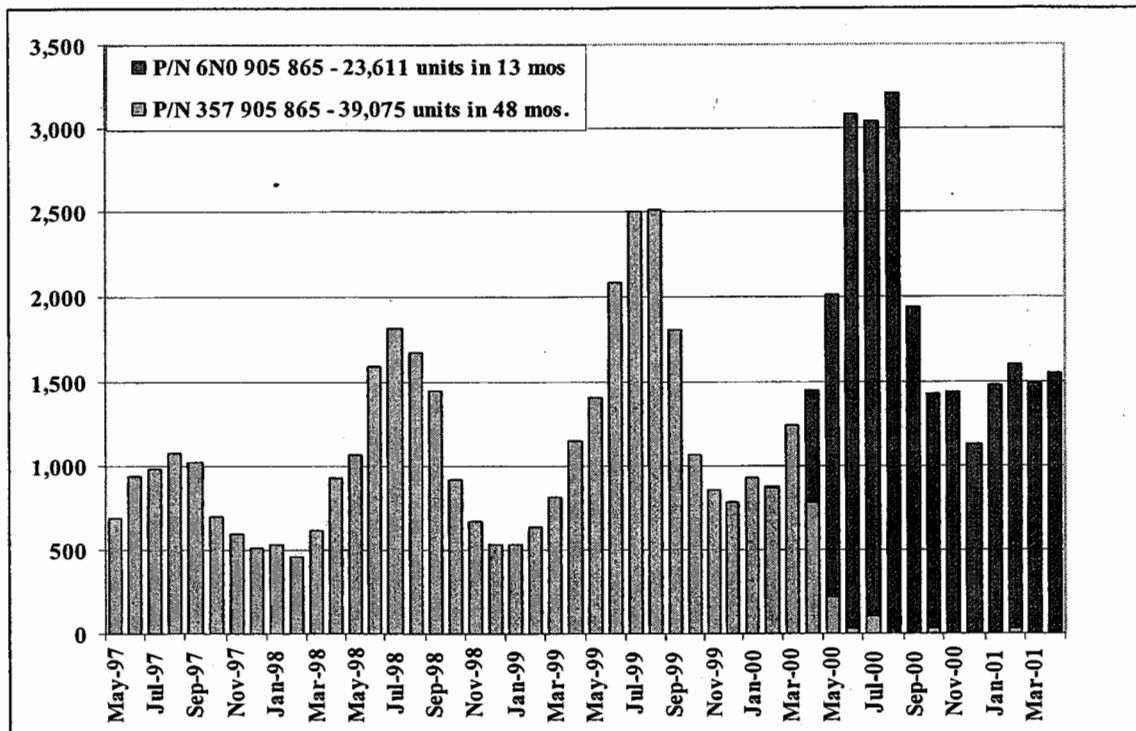
FIGURE 2. Ignition Switch Sales Trends by Calendar Month,
48-Month Period From May-97 to Apr-01.

PART SALES: Figure 2 shows the trend in sales of the subject ignition switch and its successor in the period from May 1997 through April 2001. The data show high sales volumes with a seasonal pattern that peaks in summer months. VW noted that the subject switches are used as service replacement parts in almost 800 thousand VW vehicles.

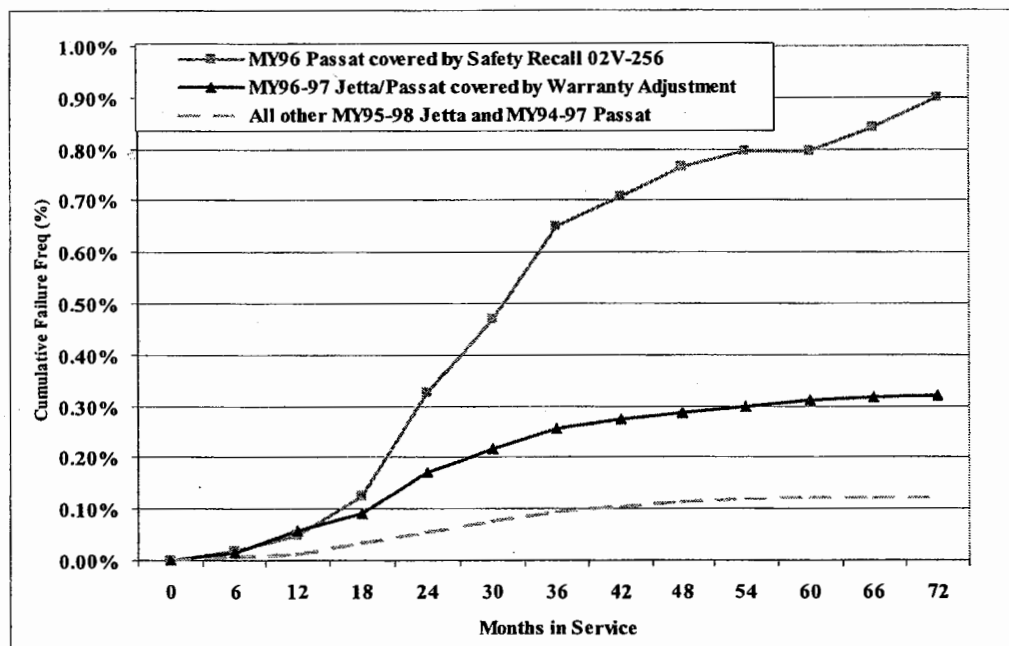
FIGURE 3. Cumulative Failure Frequencies of: (1) Recalled MY96 Passat; (2) MY96-97 Jetta/Passat Receiving Warranty Adjustment; and (3) Remaining MY95-98 Jetta and MY94-97 Passat Vehicles.

1. The reported failure data of the recalled Passat vehicles yields a failure rate that is approximately triple that of the vehicles receiving adjusted warranty coverage from VW and almost an order of magnitude greater than the remaining Jetta and Passat vehicles for which ODI collected data from VW during this investigation (Figure 3). The recalled vehicles also

show evidence of continuing failures over the last 12-months, while the other vehicles do not.
